## SUBJECT

### Rehabilitation of Chemical Sewer – *PipeArmor 100S*

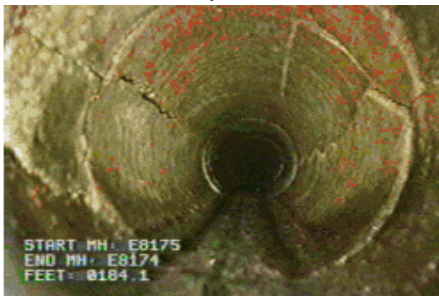
**Pre-Rehabilitated Pipeline Condition**

A chemical plant producing cellulose acetate had a chemical sewer that was at risk of leaking effluent. The VCP system was in a deteriorated condition with radial and longitudinal cracks and separated joints with cracks along the radius of the pipe. The effluent presented a high risk environmental hazard to both ground water and the local river.

- Candidate lining materials CIPP, epoxy-resins, HDPE and the polyurea were subjected to 30 day immersion in a full concentration of effluent to test for degree of chemical and heat resistance. Only the polyurea remained unremarkable. The other materials fully or partially deteriorated during the test cycle.
- The pipe system was cleaned via abrasive pigging and swabbing, and profiled, followed with the robotic installation of polyurea (PipeArmor 100S equivalent) at a thickness of 250 mil (0.25") producing a long lasting, durable monolithic liner as a chemical resistant shield to wall erosion.

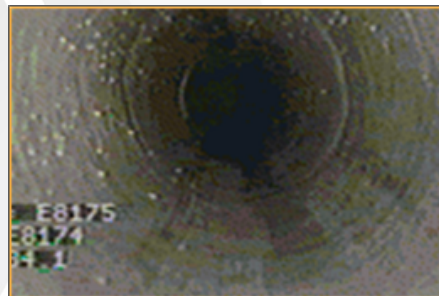
**After Rehabilitation**

- The liner sealed all cracks and perforations. The chemical sewer has been in full service 24 hours a day, seven days a week since the application in 2005, and has operated without process or environmental incident. The river adjoining the plant, which would have been impacted in circumstances of a leak, is a vibrant economic staple for the local economy as a major recreational destination for fishing and kayaking.
