**SUBJECT**

**Rehabilitation/Recovery of Boiler Blow Down Line (BBDL)**

Power Generation: Cooling System Pipeline

Liner: PipeArmor 100S

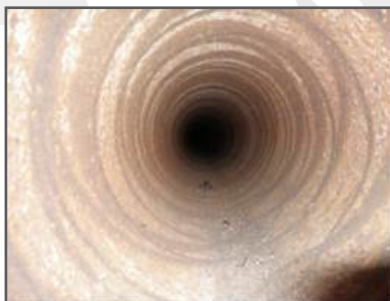
**Process Step:** The pipe walls were thoroughly cleaned of corrosion and profiled to receive the liner. Note perforations at bottom of pipe radius.

- The pipeline was cleaned using a water jet blast, abrasive pigging and foam swabbing to dry the pipe
- The pipe was robotically lined with PipeArmor 100S (equivalent) at the circumferential application of 160 mil (0.160”) to meet or exceed design loads and to arrest further pipe wall deterioration.

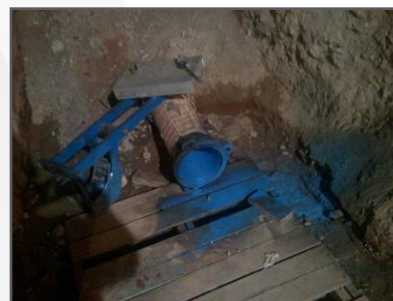
**Post Lining:** The buried pipe (under major improvements) is shown with its blue liner which protects against erosion from abrasion and corrosion.
