Rehabilitation of Deteriorated Water Transmission Pipeline

Drinking Water Supply: *PipeArmor®150SW*

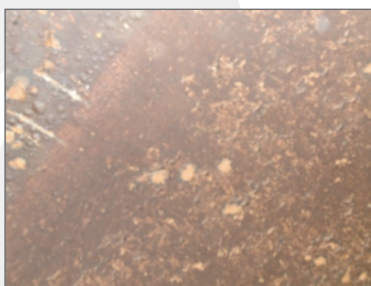
Prepped pipe wall substrate.

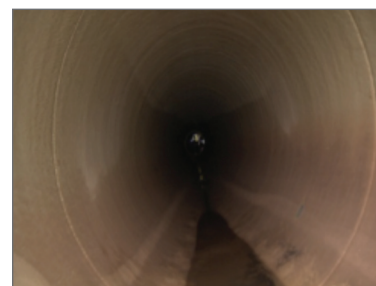
- City engineers inspected the PipeArmor® lined pipe; then after chlorination treatment, reinstated it to service.
- The robotic delivery process minimized area traffic as well as local community disruptions.
- The world’s first large diameter water supply pipeline was rehabilitated with a robotically applied self standing polyurea liner.
- After a year of in service use, the pipeline was dewatered and inspected by the city on May 10, 2014, where the liner was found unremarkable.

Completed liner at one year inspection.
