## SUBJECT

### Rehabilitation of Deteriorated Sewer Force Main

Wastewater System: *PipeArmor® 160SW*

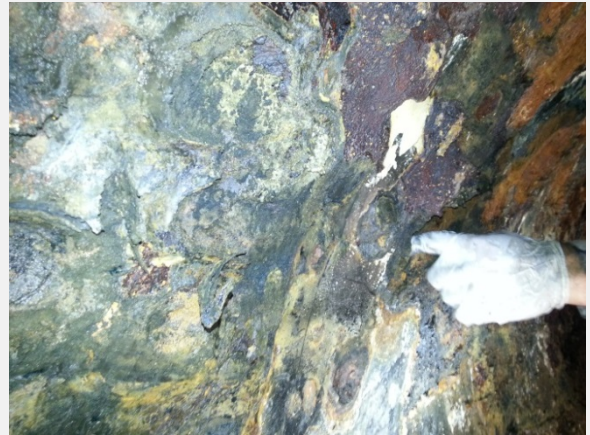
- The deteriorated section of pipeline contained a number of large perforations and thin wall surface areas.
- No upstream or downstream access presented significant challenges to other rehabilitation technologies.

**Subject Wastewater Line:** The deteriorated pipe section post-cleaning and pre-lining. Evident is significant wall loss and major perforations from aggressive H<sub>2</sub>S erosion.

- The deteriorated pipe section was prepared to an SSPC – SP2 specification.
- A camera inspection was conducted to assess the condition of the compromised pipe.
- The pipe system received a full structural liner engineered for external loading by the robotic installation of PipeArmor® 160SW.

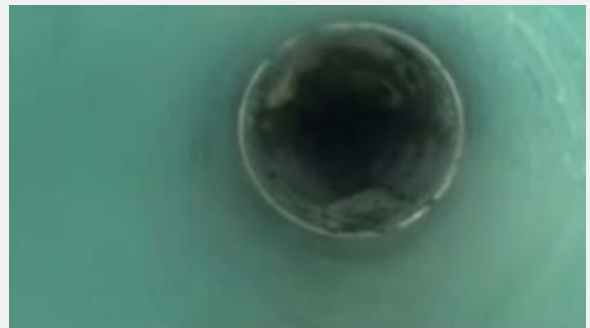
**Installed PipeArmor:** Shown in foreground is the completed PipeArmor® polymer pipe-in-pipe. In background, for contrast is the downstream section which remains in service in its original state.
